Foreshore Inventory and Mapping
**KALAMALKA & WOOD
LAKE**

Prepared For:
Okanagan Collaborative Conservation Program

Prepared By:
Ecoscape Environmental Consultants Ltd.

March, 2010
File No.: 09-370

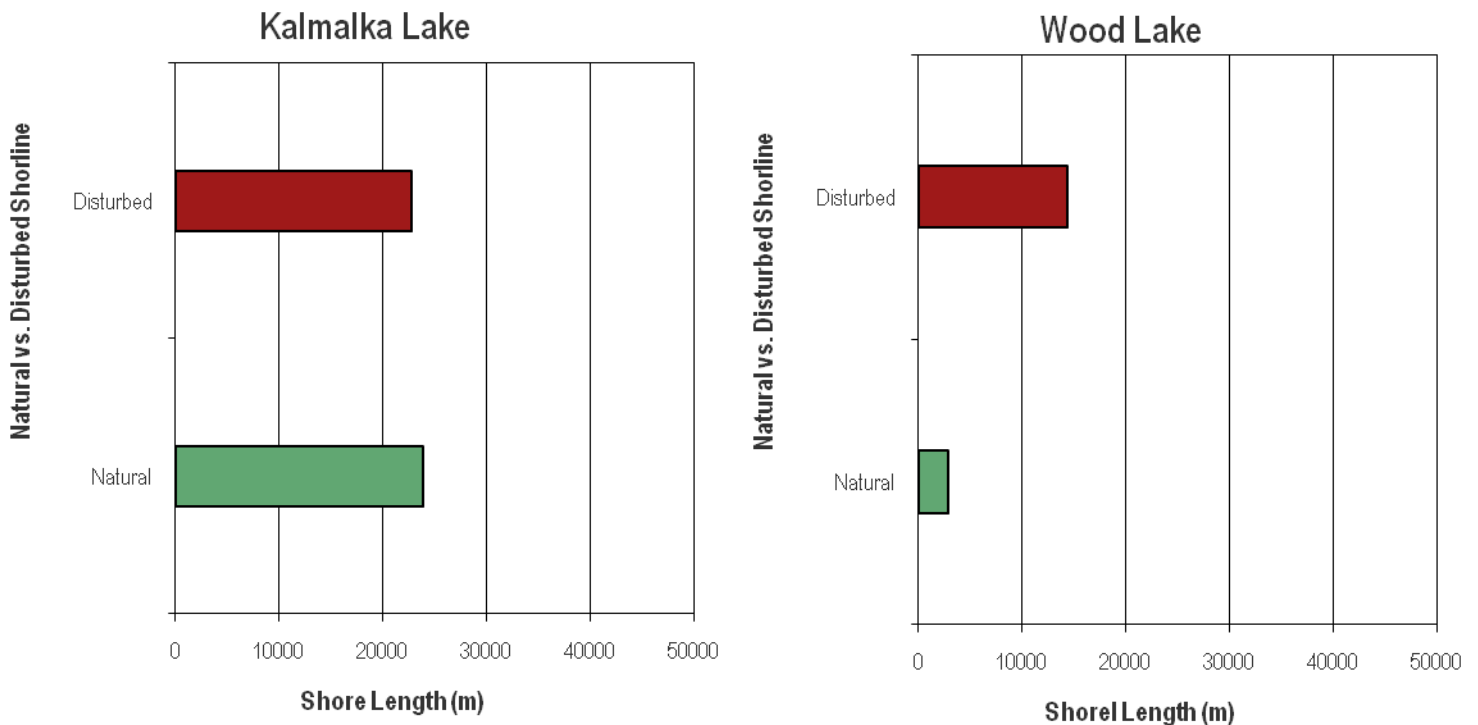
Figure 2 The total shoreline length that is either natural or disturbed on Kalamalka and Wood Lake.

Foreshore Inventory and Mapping was completed on 46,669 m (46.6 km) of shoreline on Kalmalka Lake and 17,231 m (17.1 km) on Wood Lake. The total length of disturbed shoreline on Kalamalka Lake was 22,794 m (22.8 km) and the total length of natural shoreline was 23,875 m (23.9 km). This level of disturbance represents nearly 50% of the total shoreline length (Figure 2). On Wood Lake, the total length of disturbed shoreline was 14,326 m (14.3 km) and the total length of natural shoreline was 2,906 (2.9 km).

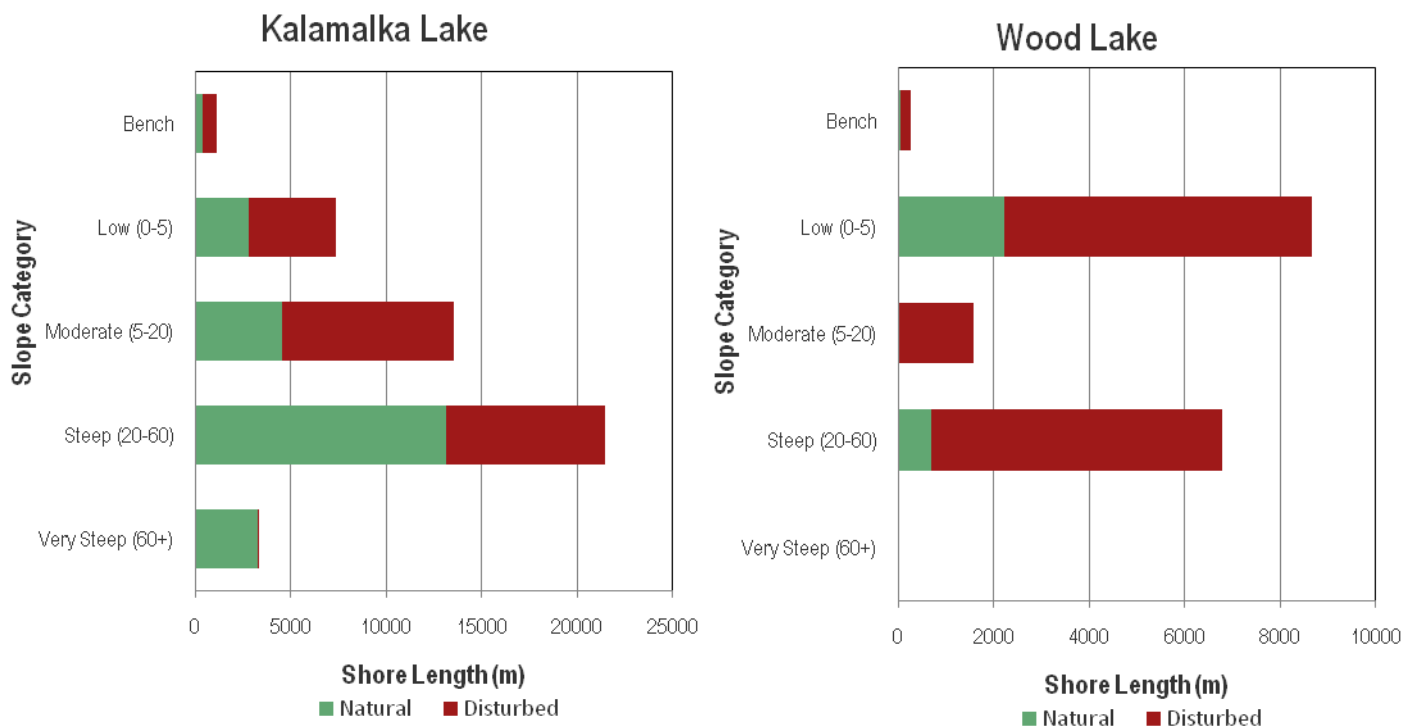
Figure 3 The total shoreline length that is either natural or disturbed within the different slope categories of Kalamalka and Wood Lake.

Areas of a lower gradient tend to have the highest level of disturbance, likely because they are easier to develop. Benches, Low and Moderate gradient areas on Kalamalka Lake were disturbed along 69.8% (0.8 km), 62.4% (4.6 km) and 66.8% (9.0 km) of their respective shore lengths within these slope categories. Along steeper shorelines in Kalamalka Lake, disturbance only occurred along 39.0% (13.1 km) and 1.7% (0.05 km) of the steep and very steep shore lengths respectively.

In Wood Lake, many steep shoreline areas were heavily disturbed when compared to Kalamalka Lake. This difference is attributed to the rail and highways that occur along the shoreline in many areas. In Wood Lake, Benches, Low, and Moderate gradient areas were disturbed along 90.1% (0.2 km), 74.4% (6.4 km), and 100% (1.5 km) of their shore lengths respectively within these slope categories. Steeper shorelines in Wood Lake were disturbed along 90.1% (6.1 km) of the shoreline.

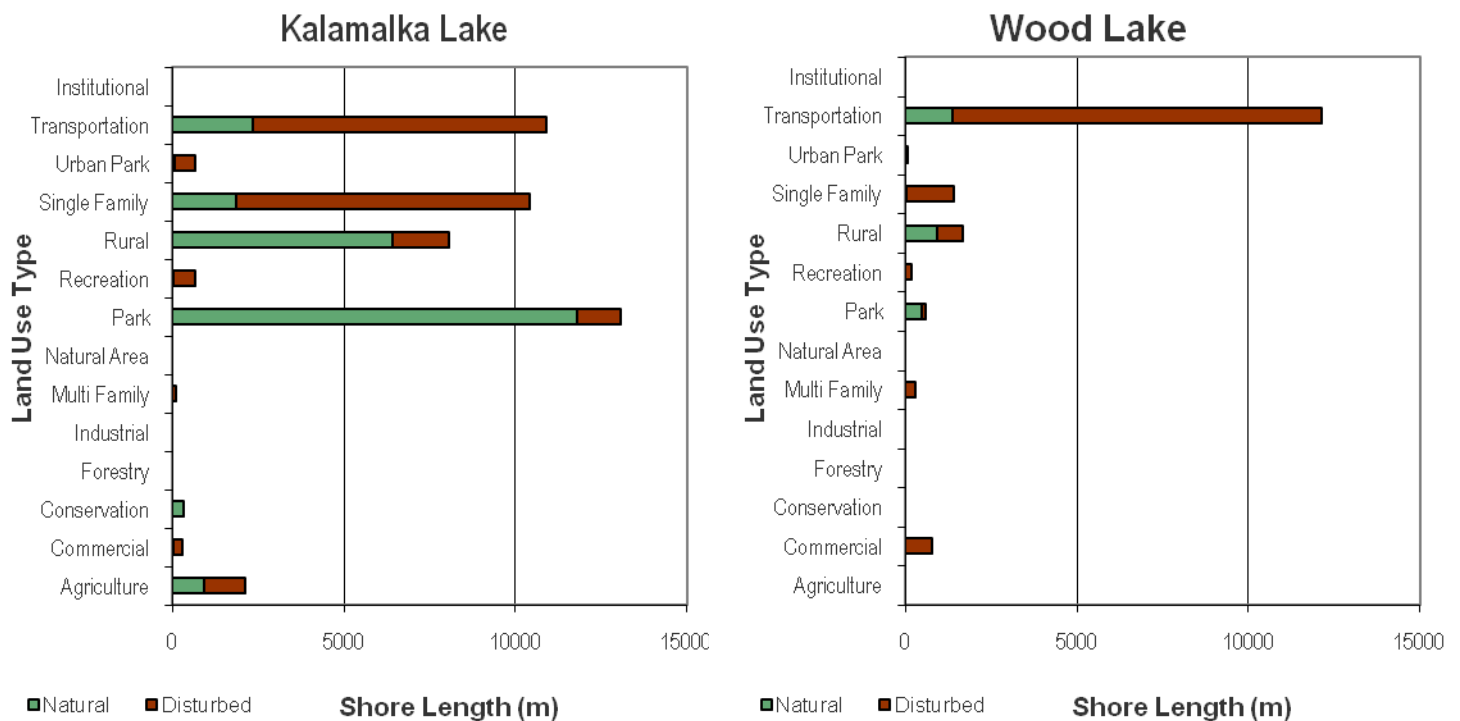
Figure 3 presents the natural and disturbed shore length by the different types of land use types occurring around Okanagan Lake South.

Natural parks areas were the most prevalent land use along the Kalamalka Lake shoreline, representing approximately 28% of the shoreline or 13.1 km. Within these natural parks areas, the shoreline was 90.3% natural and 9.7% disturbed. Transportation was the next most common land use observed along the Kalamalka Lake Shores, accounting for 23.3% of the shoreline or 10.9 km. Within transportation land use areas, the shoreline was approximately 78.3% disturbed and 21.7% natural. Single family residential areas were the next most prevalent land use, occurring along 22.3% of the shoreline or 10.4 km. Single family residential areas were highly disturbed, with 82.0% of their shore length disturbed due to factors such as riparian vegetation loss, retaining walls, etc.. Rural areas represented approximately 8.1 km (17.3%) of shoreline. Within these residential areas, over 79.9% of the shoreline was natural.

Transportation land uses along Wood Lake were predominant, accounting for 70.5% of the shore length or 12.1 km. Within these transportation land use areas, the shoreline was 88.6% disturbed due to factors such as lake infill. Rural areas were the next most common land use observed around Wood Lake, and accounted for 9.9% of the shoreline. Within these rural areas, 54.4% of the shore length was natural and 45.6% was disturbed. Single family residential areas accounted for 8.3% of the shore length and within these areas only 2% of the shore line remains in natural condition.

Multifamily and commercial areas were present along both Wood and Kalamalka Lake. Shorelines in multi family of both lakes were 100% disturbed. Within commercial areas, disturbances along the shoreline in excess of 90% in both Wood and Kalamalka Lake.

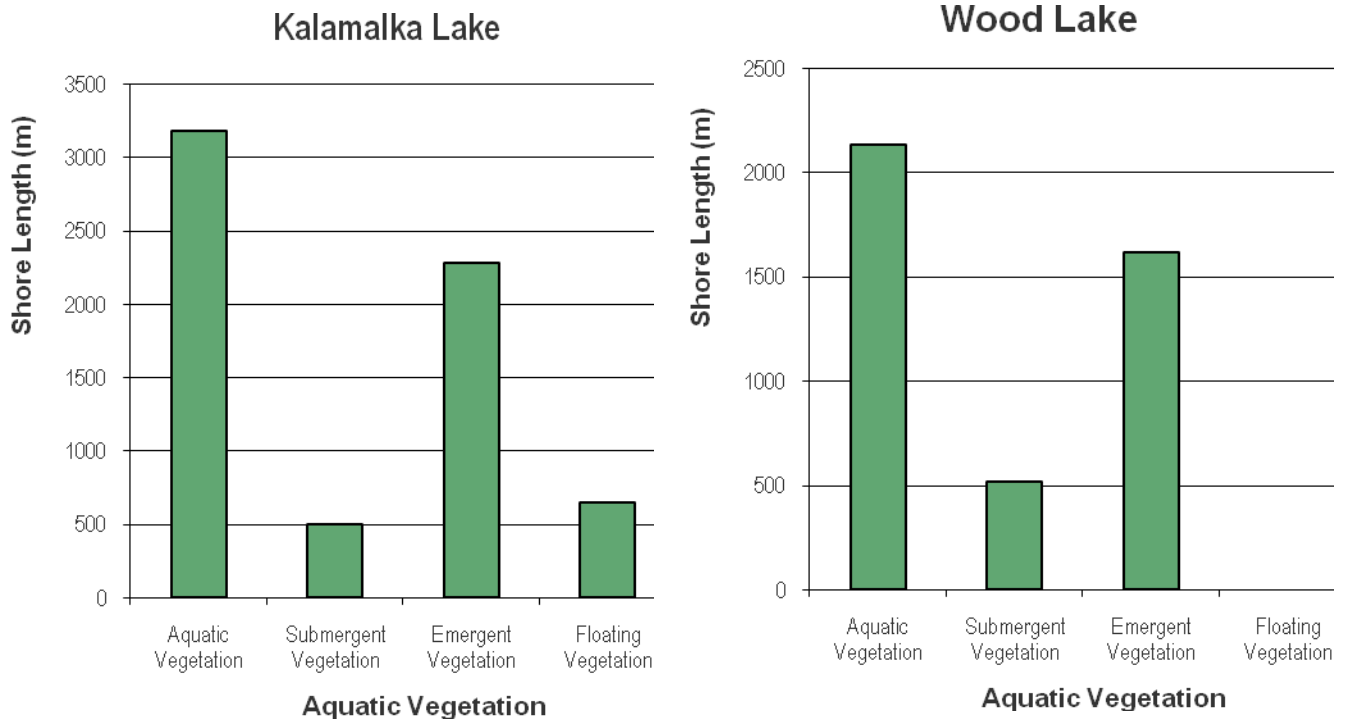
Figure 5 presents the total shoreline length that has aquatic, submergent, emergent, and floating vegetation along Kalamalka and Wood Lakes.

There is approximately 3.2 km of the shoreline of Kalamalka Lake that has aquatic vegetation, which represents approximately 6.8% of the total shoreline length in the Lake. The total area of both dense and sparsely vegetated areas with aquatic vegetation (floating, emergent, or submergent) is 24,859 m². The most common vegetation type observed was emergent vegetation, which occurred along 4.9% (2.3 km) of the Kalamalka Lake shore length. Floating and submergent vegetation accounted for 1.1% (0.5 km) and 1.4% (0.7 km) of the shorelines respectively. Detailed mapping of submergent vegetation was difficult due to the large littoral areas observed. It is highly probable that there are additional submergent vegetation areas that have not been inventoried as part of this assessment.

In Wood Lake, aquatic vegetation occurred along 12.4% of the shoreline or 2.1 km. Emergent vegetation occurs along 9.4% (1.6 km) of the shoreline. Submergent vegetation was also present and occurs along 3.0% or 0.5 km). As above, detailed mapping of submergent vegetation was difficult.

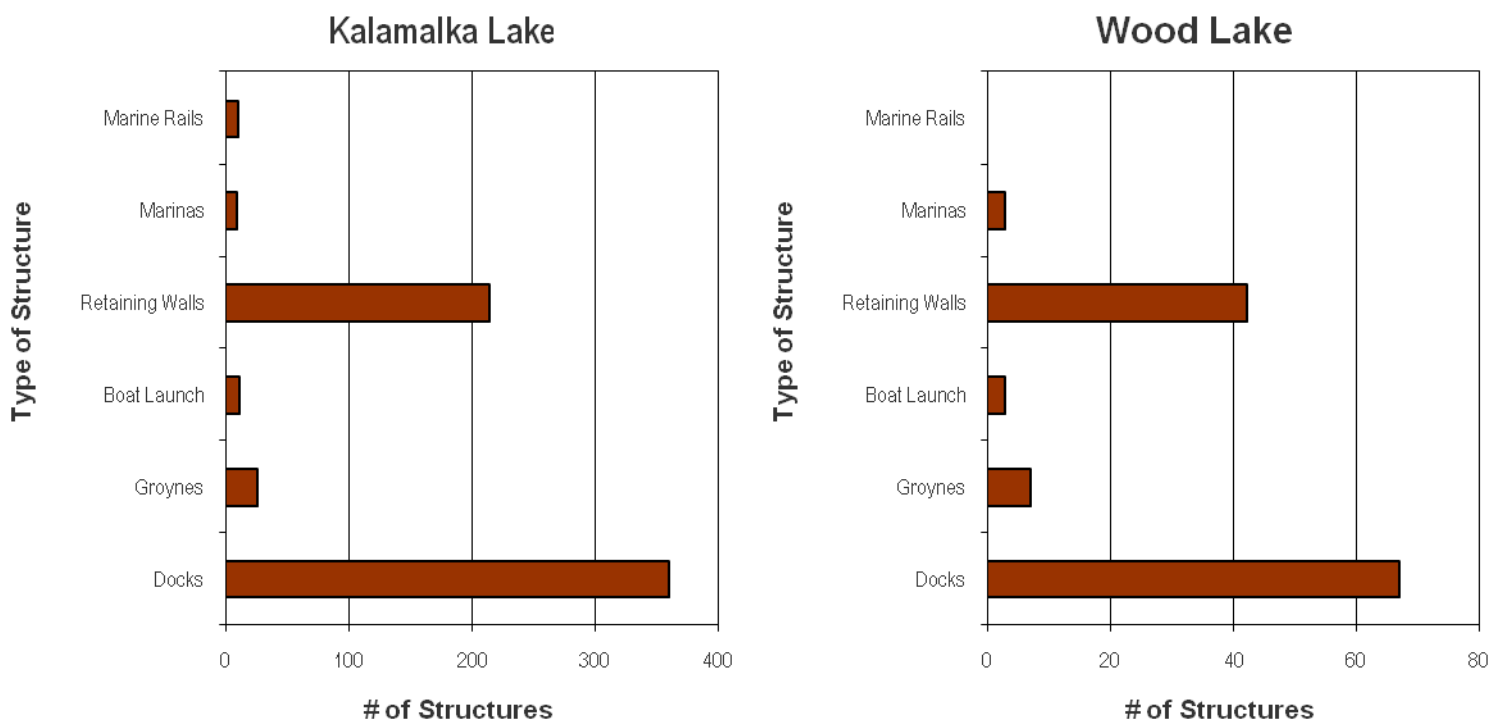
Figure 6 presents the total number of different shoreline modifications that occur around Kalamalka and Wood Lake.

On Kalamalka Lake docks were the most commonly observed type of shoreline modification. There were a total of 360 docks on the lake. Retaining walls were the second most common modification observed, with 213 retaining walls being observed. Groynes were observed on the lake and there was a total of 26 present. There are a total of 9 marinas with greater than 6 boat slips and 11 boat launches. There were a total of 10 marine rails observed on Kalamalka Lake. The above summarizes the current structures that occur on, over, and around Kalamalka Lake

On Wood Lake, docks were also the most commonly observed modification, with a total of 67 structures present. A total of 42 retaining walls were observed on the lake. There were also a total of 7 groynes, 3 boat launches, and 3 marinas with greater than 6 slips.

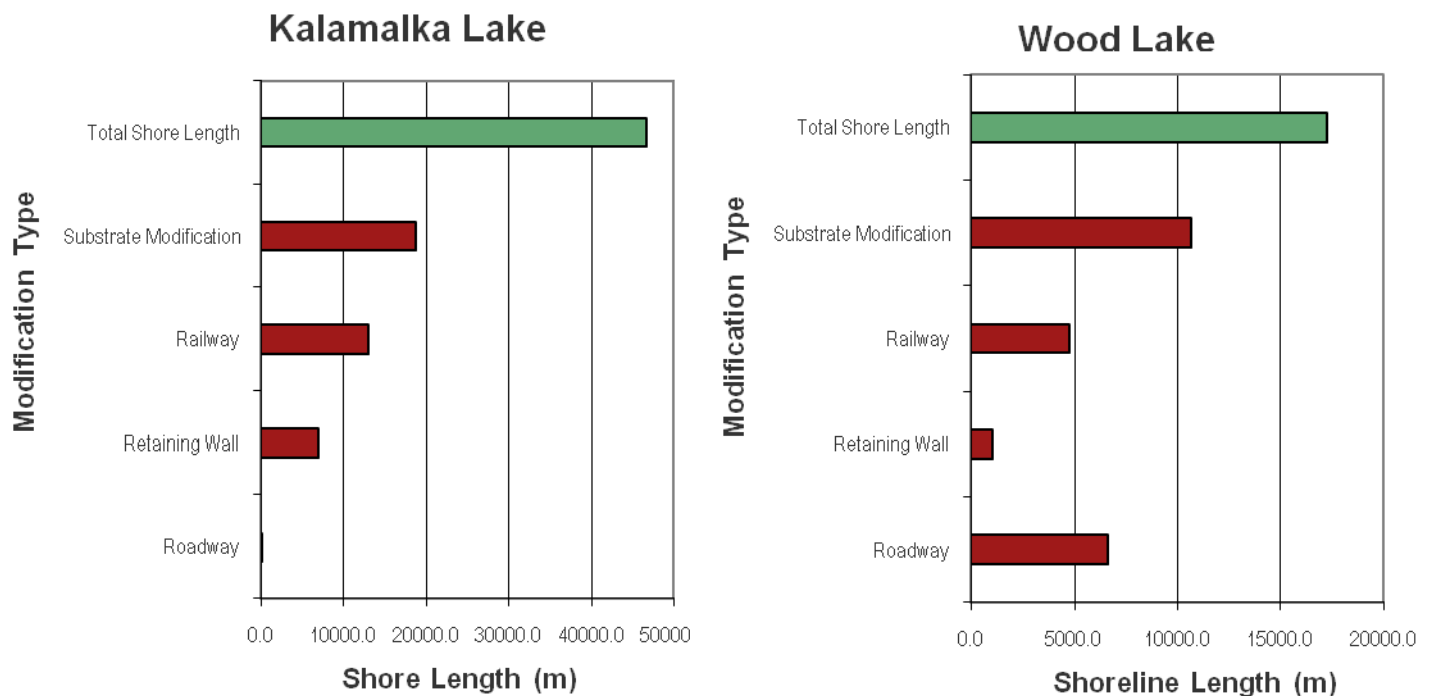
Figure 7 presents the total shoreline length that has been impacted by substrate modification, road and railways, and retaining walls along Kalamalka and Wood Lake.

The percentage of the shoreline that was impacted by transportation (roads, railways), retaining walls, and substrate modification was recorded along Kalamalka Lake to allow an estimation of the approximate shoreline length that has been affected by these different mechanisms (Figure 7). By far, substrate modification was the most substantial impact that was observed along the shoreline. In total, it is estimated that 40% or 18.8 km of shoreline has experienced some form of substrate modification in the form of beach grooming or highway fills. Transportation impacts from railways were the next most prevalent modification and were present along 28% or 13.0 km of shore line. Retaining walls have also had a substantial impact to the shoreline and it is estimated that 15% or 7.0 km of the shore has been impacted by retaining walls. Retaining walls were observed both above and below the high water level (i.e., some walls had a visible water line indicating that they have encroached below the high water level).

On Wood Lake, a similar scenario was also present, except that the lake has also been impacted by roadways. Substrate modification was present along 62% (10.7 km) of the lake. Roadway impacts were present along approximately 38% or 6.7 km of the lake. Railway was associated with approximately 28% or 4.8 km. Finally, retaining walls were present along 6% or 1.1 km.

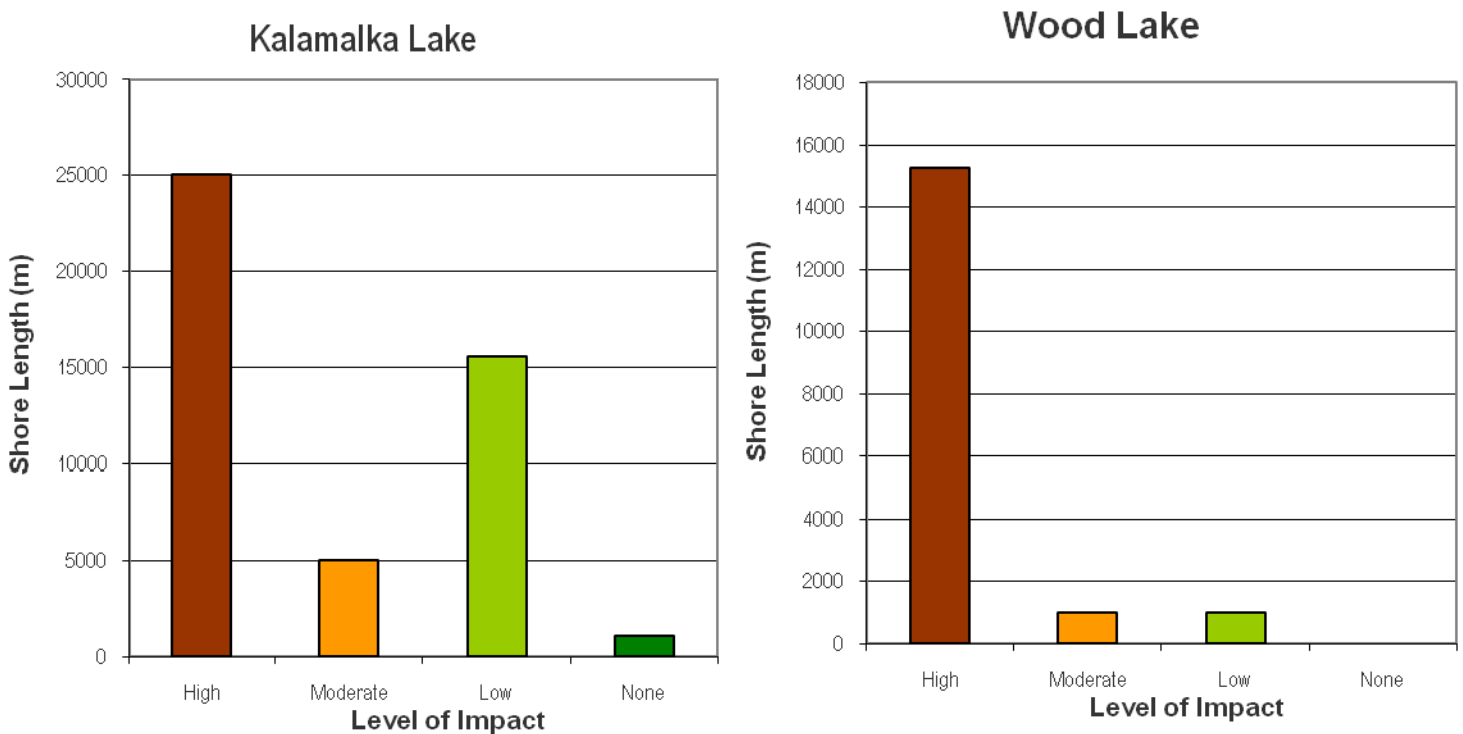
Figure 8 presents the level of impact (High, Moderate, Low, or None) observed along Kalamalka and Wood Lake.

The foreshore modifications by the different mechanisms described above for Kalamalka Lake have resulted in a high level of impact around approximately 53.7% or 25.0 km of the shoreline. Areas of moderate and low impact account for about 10.7% (5.0 km) and 33.32% (15.6 km) of the shoreline respectively. Kalamalka had approximately 2.3% of the shoreline that remained 100% natural in condition.

On Wood Lake, 88.5% (15.2 km) of the shoreline has experienced a high level of impact. Moderate and low impact shorelines were present along 5.7% (1.0 km) and 5.8% (1.0km) of the shoreline respectively.

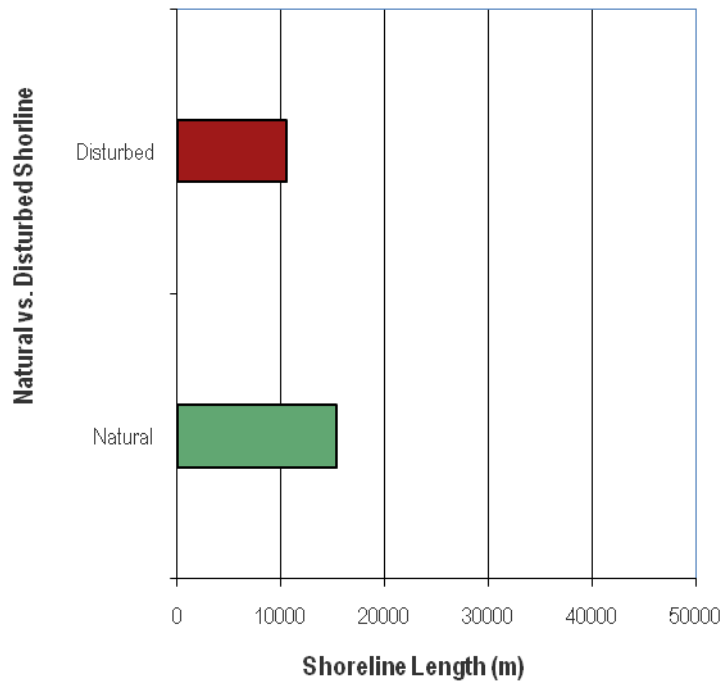
Figure 1: The total shoreline length that is natural and disturbed within Regional District North Okanagan Electoral Area B.

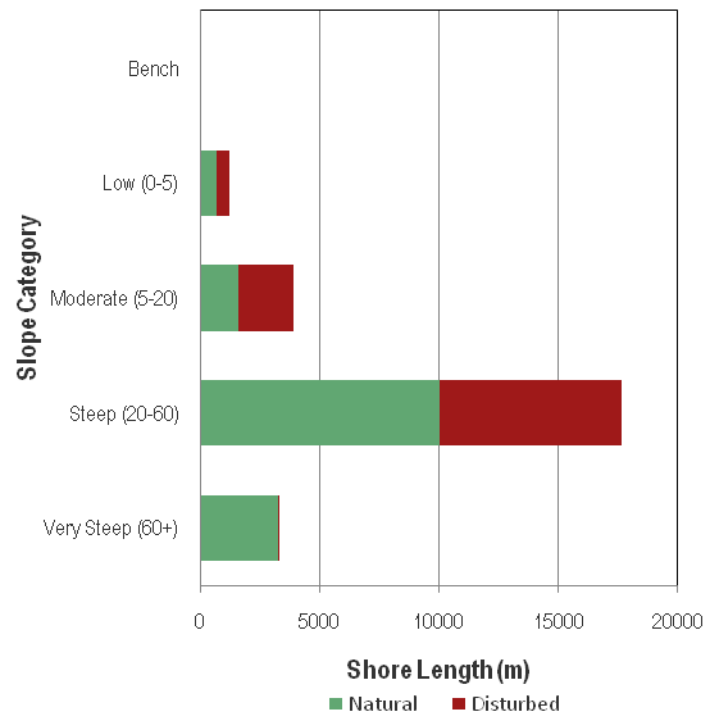
Figure 2: The total shoreline length that is natural and disturbed within each different slope category in Regional District North Okanagan Electoral Area B.

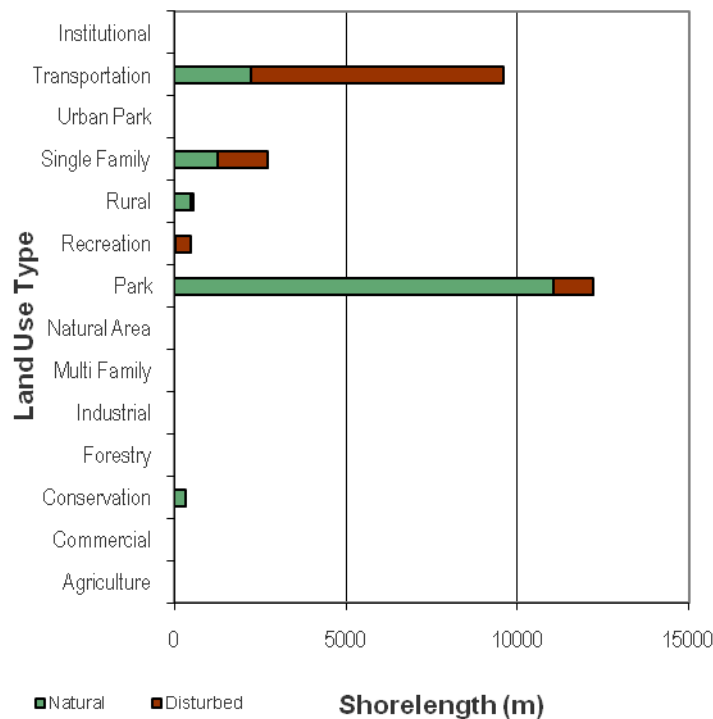
Figure 3: The total shoreline length that is natural and disturbed within each different land use category in Regional District North Okanagan Electoral Area B.

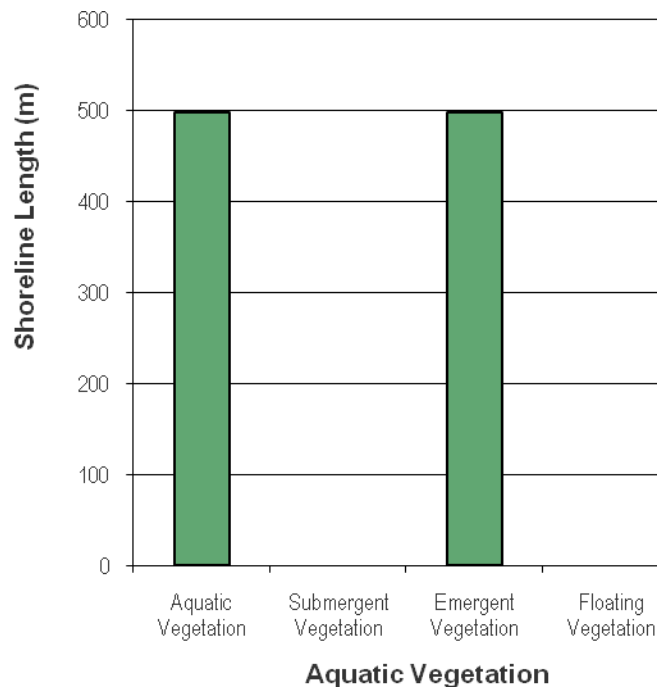
Figure 5: The total shoreline length with aquatic, submergent, emergent, and floating vegetation within Regional District North Okanagan Electoral Area B.

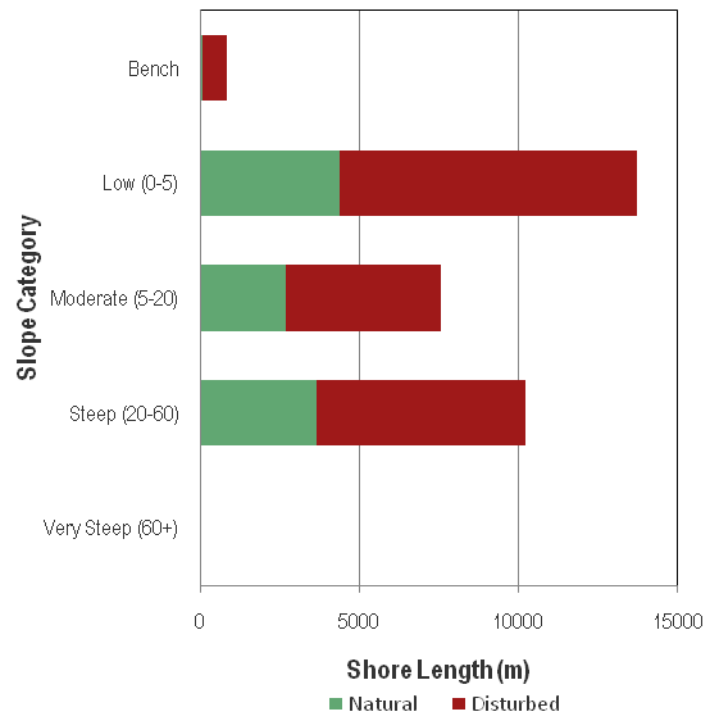
Figure 2: The total shoreline length that is natural and disturbed within each different slope category in The District of Lake Country.

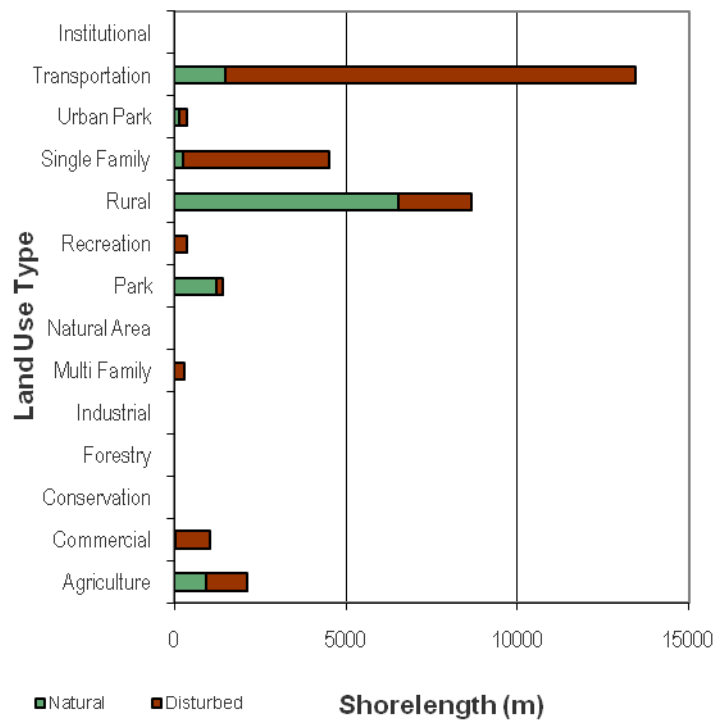
Figure 3: The total shoreline length that is natural and disturbed within each different land use category in the District of Lake Country.

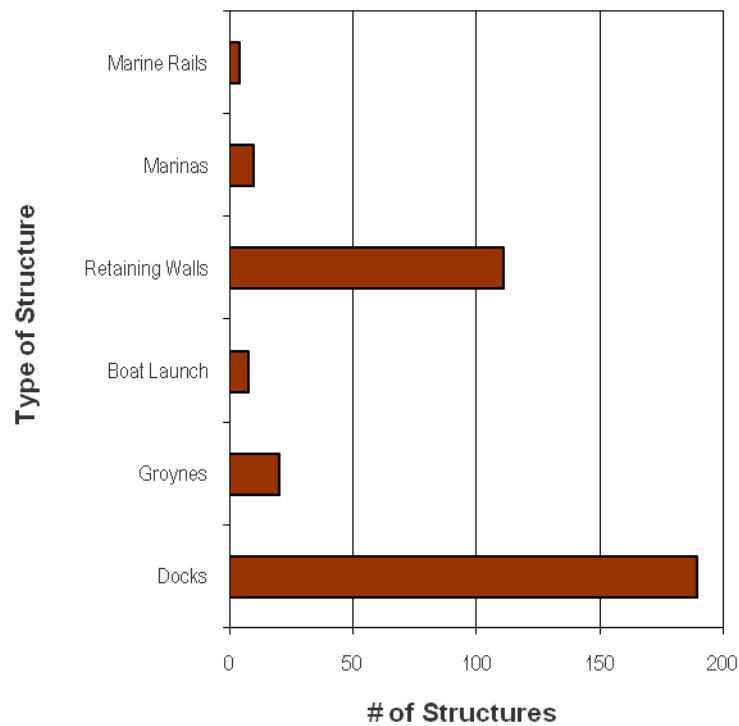
Figure 6: The total number of different modifications found within the District of Lake Country.

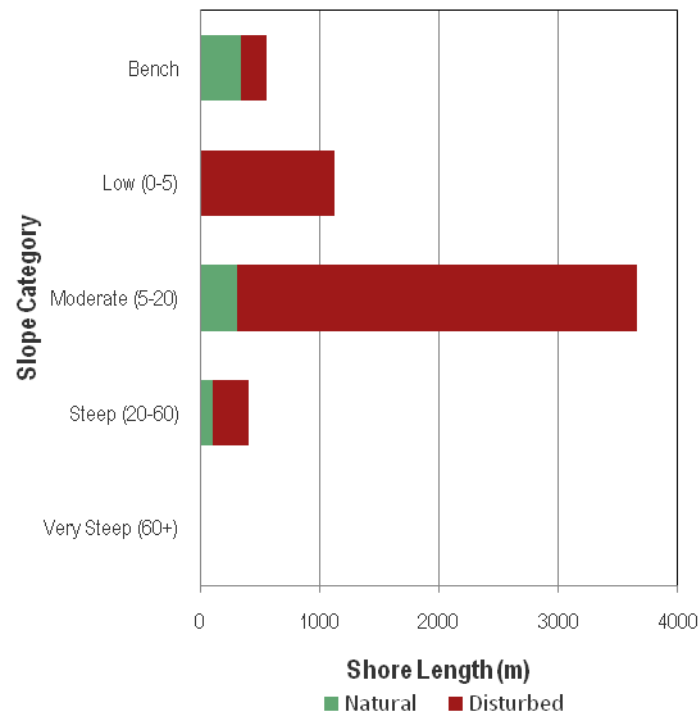
Figure 2: The total shoreline length that is natural and disturbed within each different slope category in the District of Coldstream.

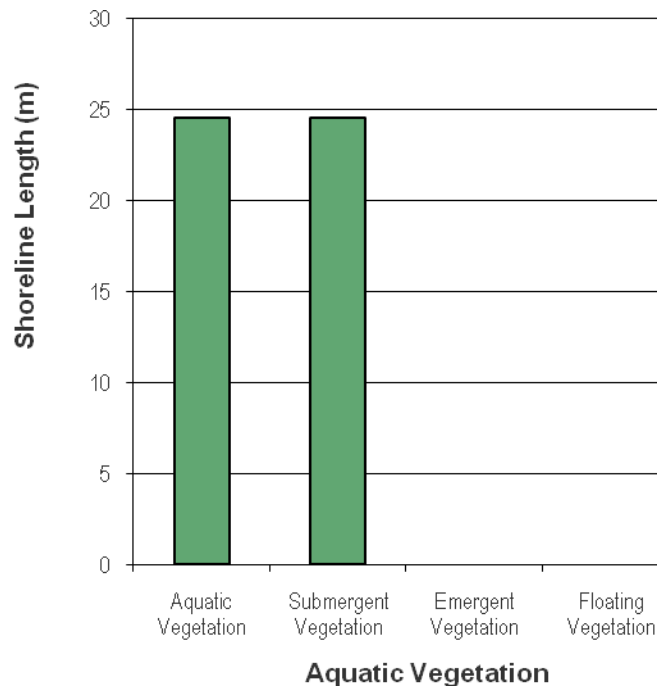
Figure 5: The total shoreline length with aquatic, submergent, emergent, and floating vegetation within the District of Coldstream.

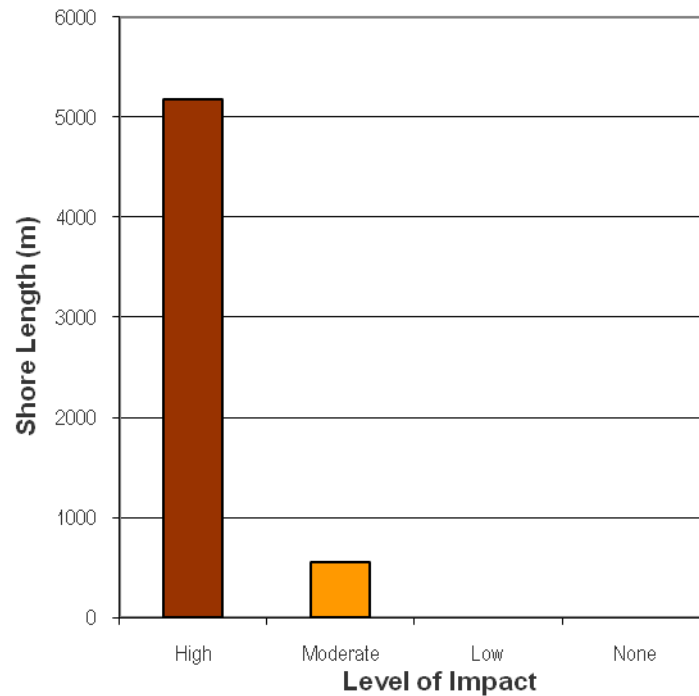
Figure 8: The Level of Impact of the shorelines within Regional District North Okanagan Electoral Area B.
