## **District of Lake Country Source to Tap Assessment of the South Kalamalka Lake Intake – July 2010.**

### **Executive Summary**

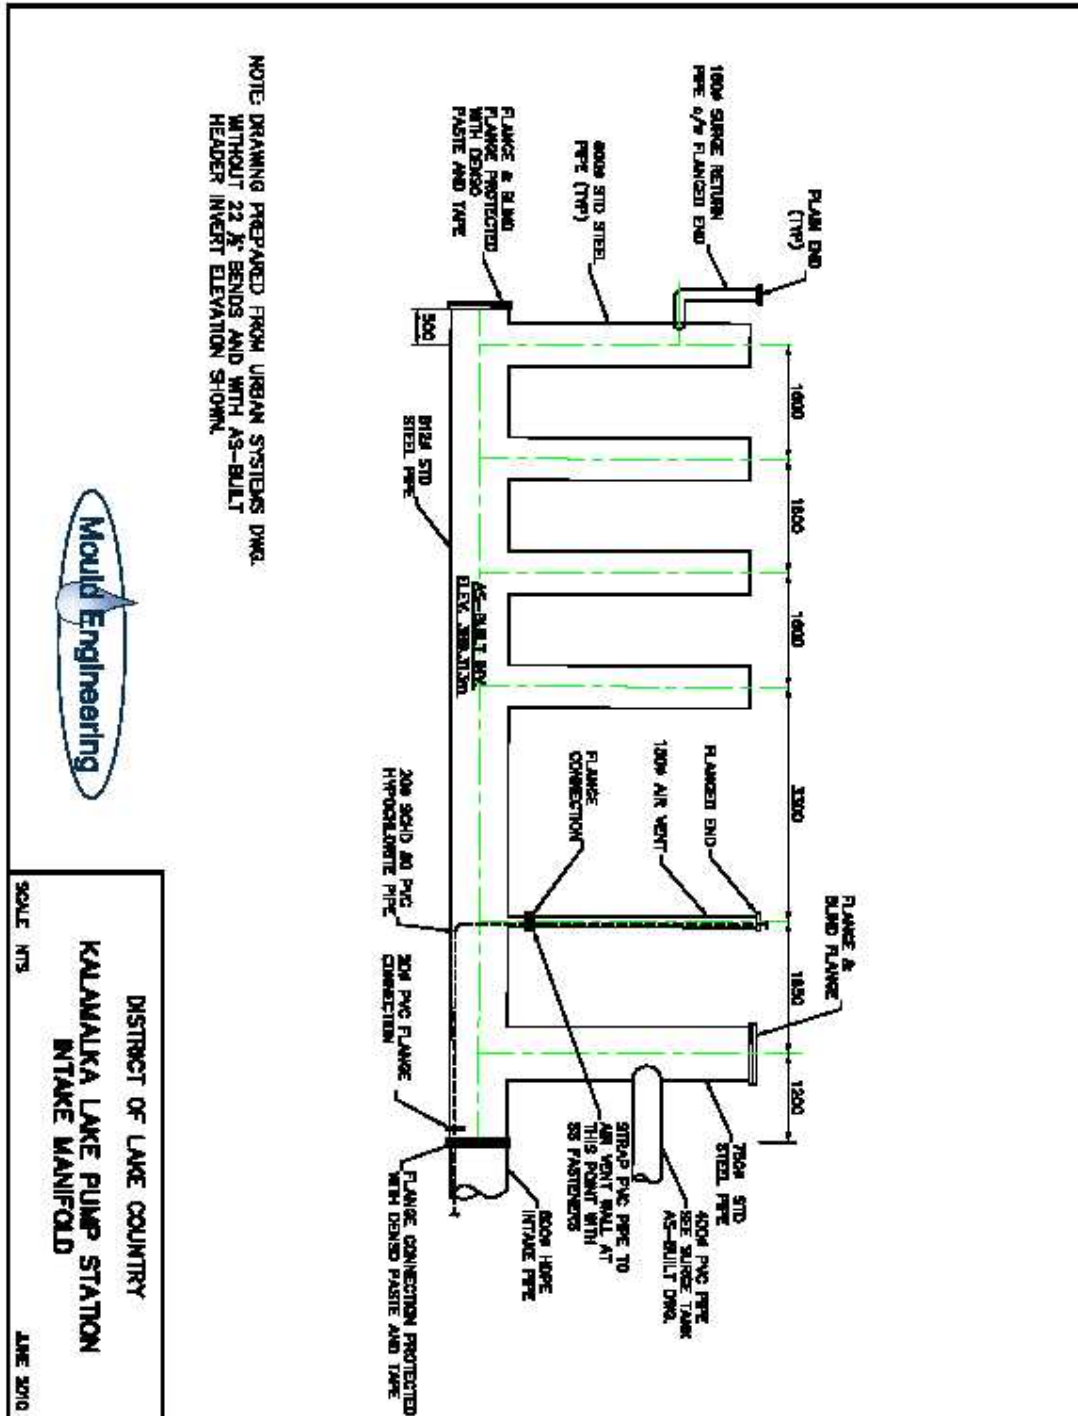
### Physical Features and Design

The DLC Kalamalka intake is located in 22 m of water and has 2 m of clearance from the substrate. The 800 mm diameter HDPE intake pipe is 440 m long measured from the lake shore. The intake manifold is detailed in the diagram below:

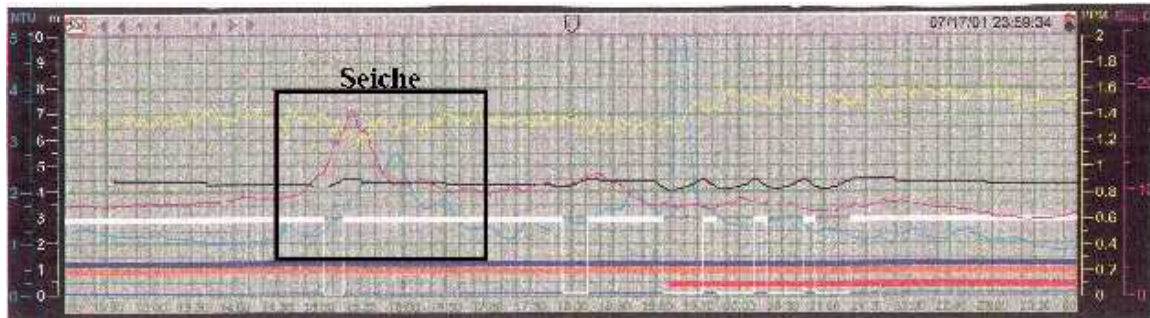
**Figure 2.1: Seiche-Induced Temperature and Turbidity Spike at Intake**

Temperature and turbidity spike measured at GVW N-Kal Intake — Temperature — Turbidity

Seiches are wind-driven tipping of a lake's water layers during the summer. Seiches cause the water layers to oscillate for days after a wind storm. For a fixed intake, seiches mean a rapid fluctuation in water temperature and turbidity as the intake alternately draws water from the surface layer and the deep hypolimnion (Figure 2.1).

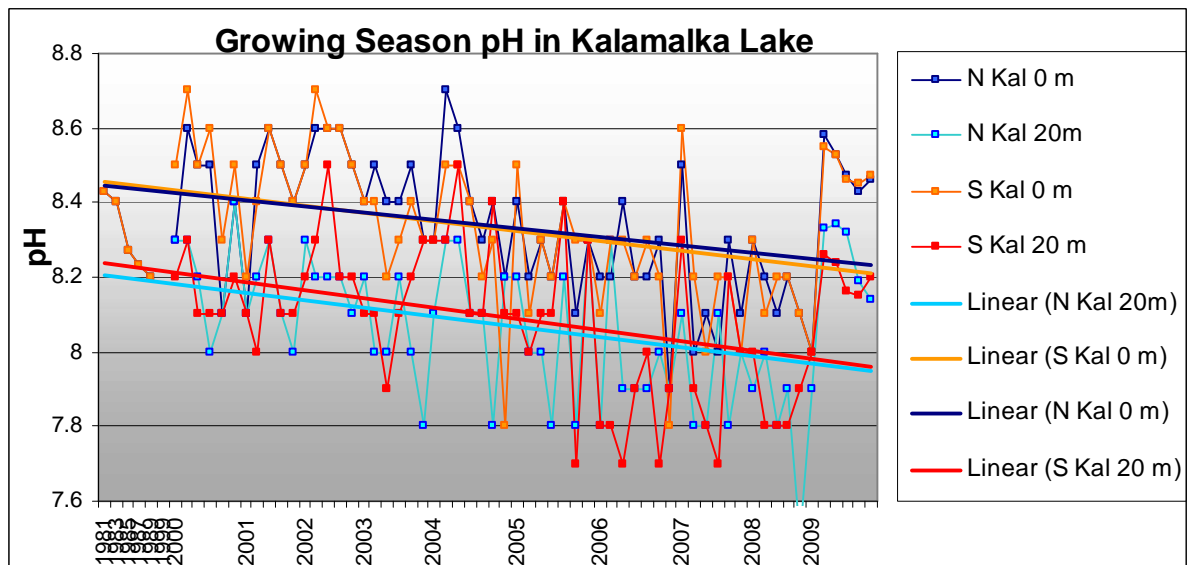
FIGURE 2.4: Growing Season pH in Kalamalka Lake 1981- 2009

**pH** During the course of this study, pH appears to be in slow decline. The trend toward lower pH may signal a reduction in the intensity of the marl precipitation events. Overall, the linear regression lines still show decreasing pH but there is considerable pH oscillation shown in the lines with markers in Figure 2.4.

NOTE: This graph emphasizes data from 2000 to present

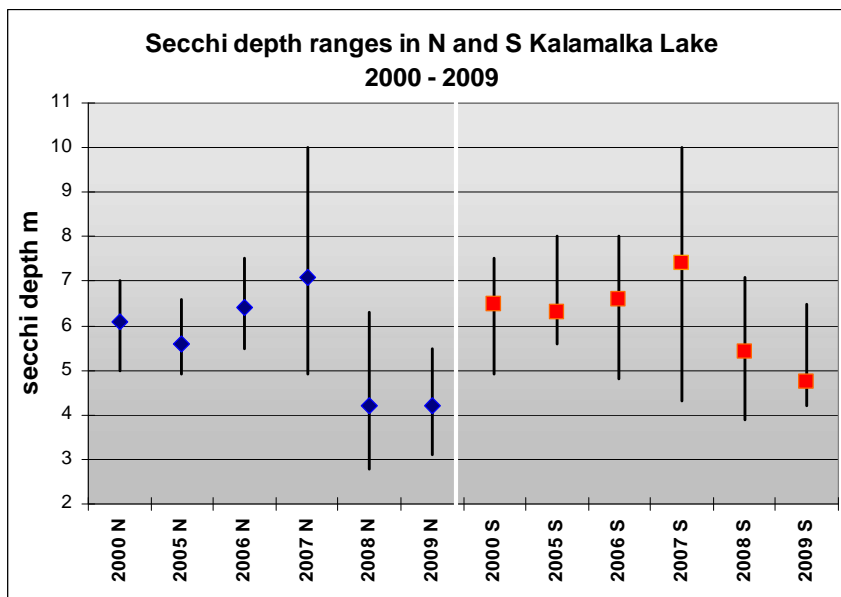
**Figure 2.5: Secchi Depth Range and Average in North and South Kalamalka Lake 2000 - 2009**

**Water Transparency** Historic secchi depths measured 6 – 7 m in 1935 and 3.8 – 10.7 m (avg 6.5 m) from 1975 – 1988 (Bryan, 1990). Within this study, growing season secchi depths ranged from 2.8 m during spring freshet algae production to 10.1 m post-marl precipitation – a similar range to Bryan’s work. The average growing season secchi depth reacts to the size of the freshet. Large freshet years such as 2008 had lower overall secchi depths, particularly at the North end (Figure 2.5).

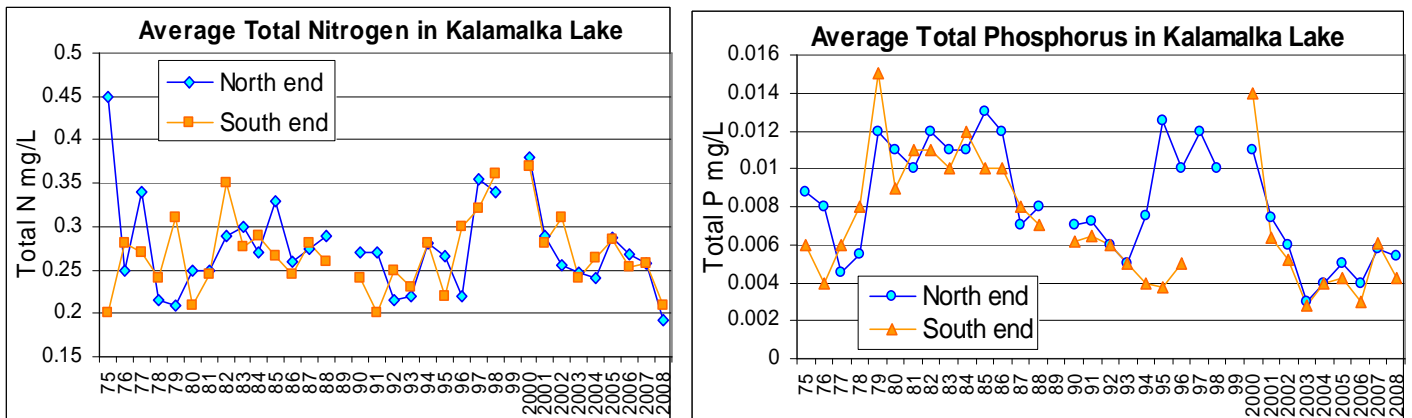
**FIGURE 2.6: Average Total N and P In Kalamalka Lake 1975 - 2008**

MoE objective = 0.008 mg/L TP for Kalamalka Lake;  
0.015 mg/L TP for Wood Lake (Nordin et al, 1988)

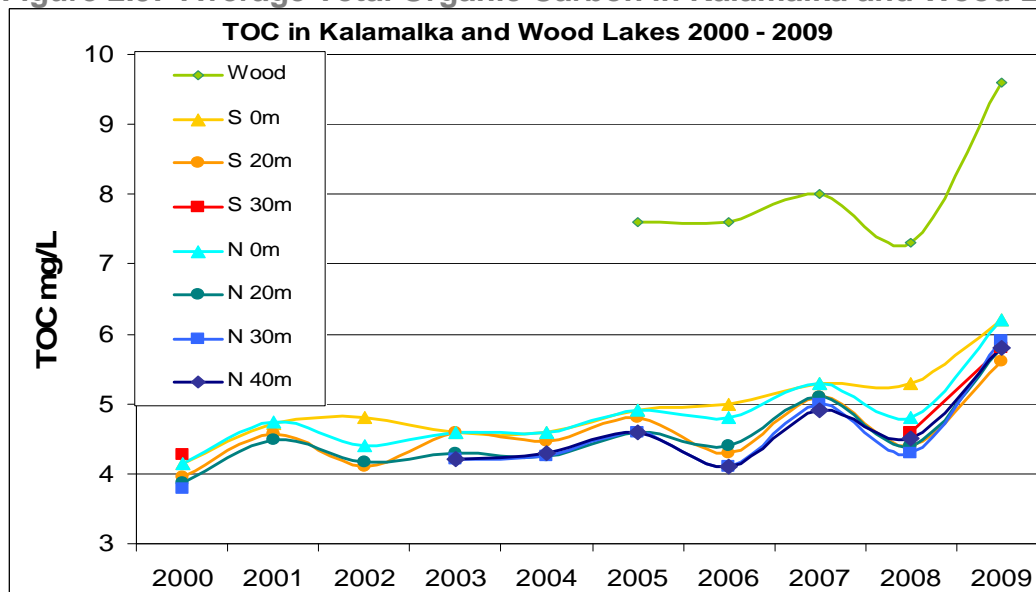
**Figure 2.9: Average Total Organic Carbon in Kalamalka and Wood Lakes**

**Total Organic Carbon (TOC)** Total organic carbon measures microflora and dissolved organic molecules and for that reason, TOC concentrations move in concert with algae growth. Historic TOC's are comparable to recent TOC measurements. In the 1980's, TOC averaged 6.2 mg/L in the South end of Kalamalka Lake, and 2.6 mg/L in the main section of the lake (Bryan, 1990). Organic carbon concentrations exceeded the B.C.WQ criteria of 4.0 mg/L through most of the growing season, particularly in surface samples because algae concentrate where light intensity is high and because pollen, leaf debris etc., accumulate on the surface (Figure 2.9). In all cases, TOC decreased with depth, however, the water quality advantage of a 30 m intake over the existing 22 m intake would be minor i.e. a 0.1 – 0.2 mg/L TOC difference.

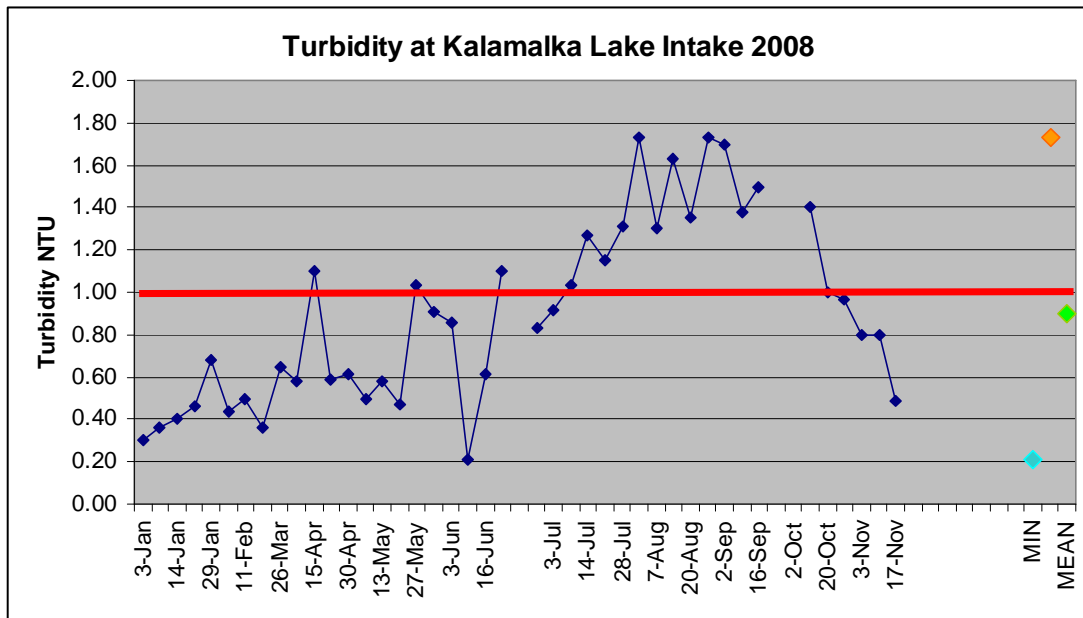
**Figure 2.10: Turbidity at South Kalamalka Lake Country Intake 2008**

**Turbidity** Turbidity is naturally high in Kalamalka Lake, near 0.4 – 1.2 NTU from July to October due in part to the marl precipitation (Figure 2.10). Other natural sources of turbidity include freshet plumes, seiches, lake overturn and algae pulses. Annual turbidity averaged 0.73 NTU in Kalamalka from 1973 – 1989. Average Kalamalka Lake turbidity appears to be relatively steady since 1990 but has decreased slightly since 2004 (Figure 2.12).

Some summers are worse for turbidity than others (Figure 2.10). 2005 and 2006 were particularly high due to seiches, extensive marling and algae production. Generally, years with large freshets have higher turbidity throughout the summer because of the "ripple effect" of the larger nutrient donation.

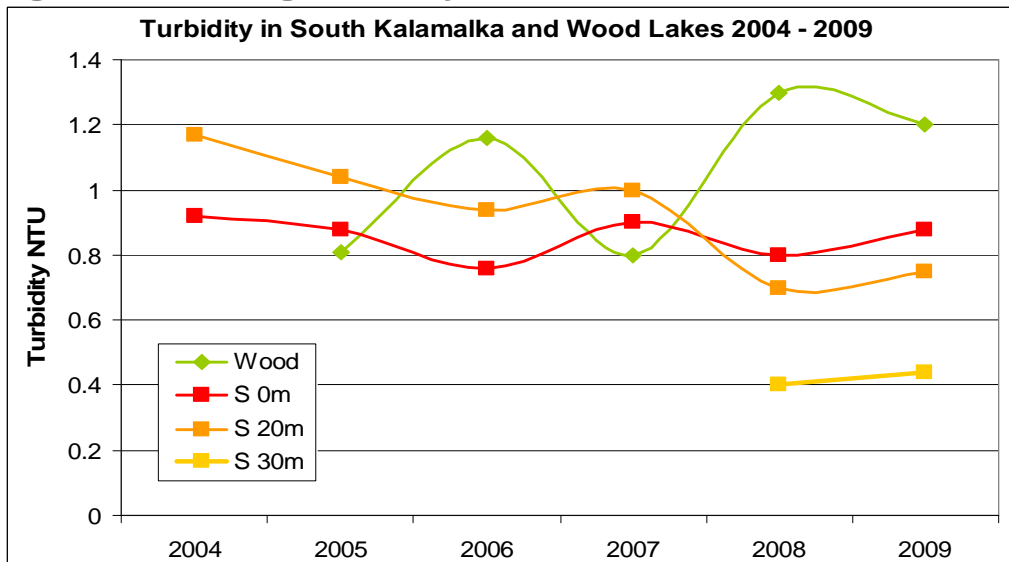
**Figure 2.12: Average Turbidity at South Kalamalka and Wood Lakes**

Measurements of turbidity collected from several points in the Oyama water system ranged from 0.24 to 2.36 with an average of 0.72 NTU. These elevated turbidities generally occurred at the end-of-line sites, but in 2007 and 2008, elevated turbidity occurred throughout the system especially after the marl precipitation developed in Kalamalka Lake. Flushing and/or additional chlorine is required to maintain residuals when marl or aquatic organic matter (algae; detritus) becomes a problem (Hansen, 2008). Turbidity was slightly higher in Wood Lake over South Kalamalka, with a turbidity pattern opposite to that of Kalamalka Lake (Figure 2.12). The reason for the opposing turbidity trends in Kalamalka and Wood Lakes is not known.

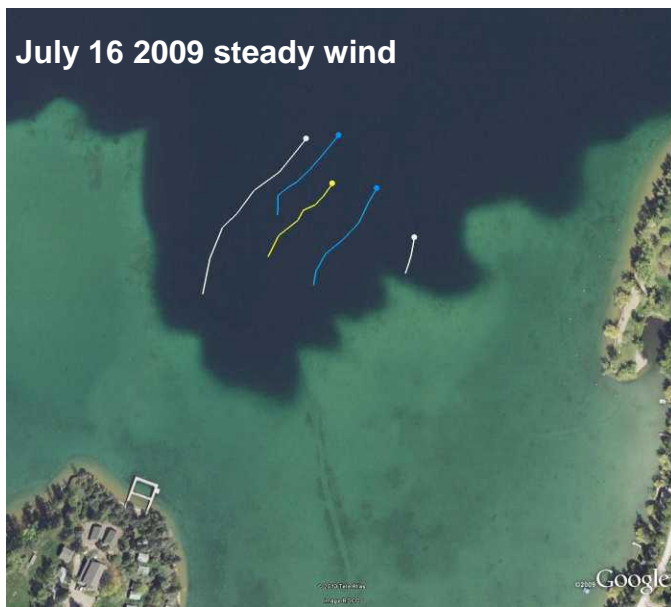
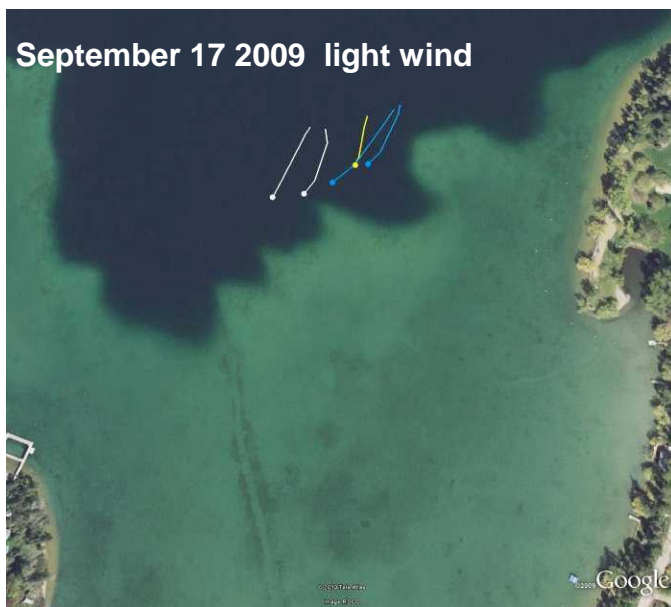
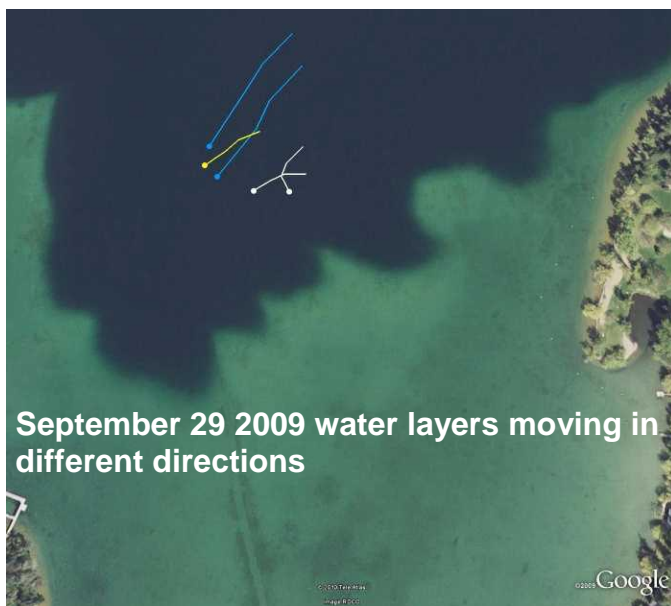
Figure 2.14 South Kalamalka Lake Drogue Trials, 2009

White Line = 5 m drogue  
Blue line = 10 m drogue  
Yellow Line = 20 m drogue  
Circle = start point

The direction of travel of the drogues was scattered, reflecting the effect of the bays, points and shallows deflecting the wind-driven currents (Figure 2.14). Contradictory travel in different water layers was often observed and was the result of seiches, deflected currents or a change in wind direction. The surface 5 m of the lake can change directions and velocity faster than deeper water can.

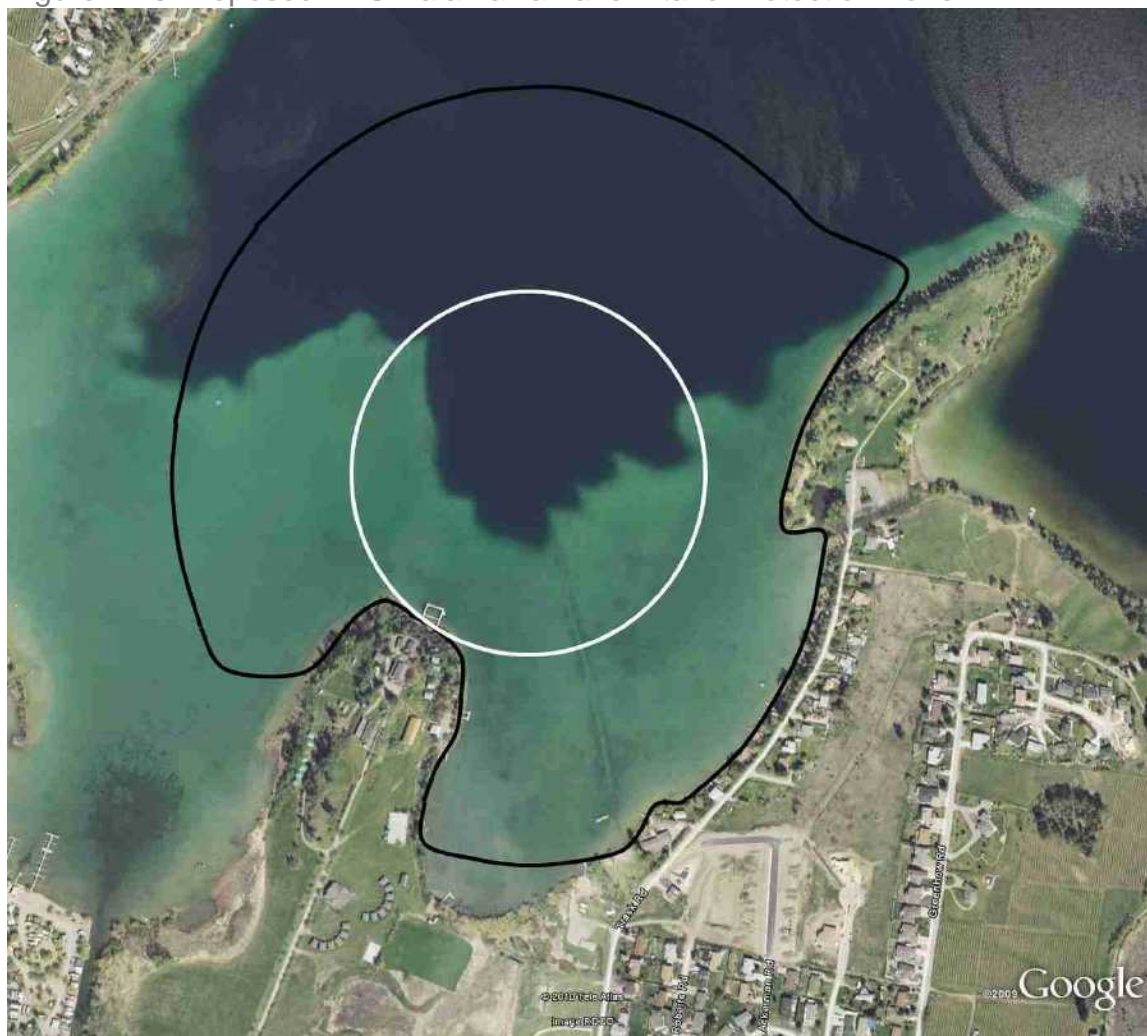
Figure 2.15 Proposed DLC Kalamalka Lake Intake Protection Zone

The white circle encompasses the area that the fastest drogues traveled in two hours with light winds.

The black modified circle encompasses the area water currents can travel in two hours with 80 % of the wind events that occur on Kalamalka Lake and is the recommended Intake Protection Zone (IPZ) (464 m radius).

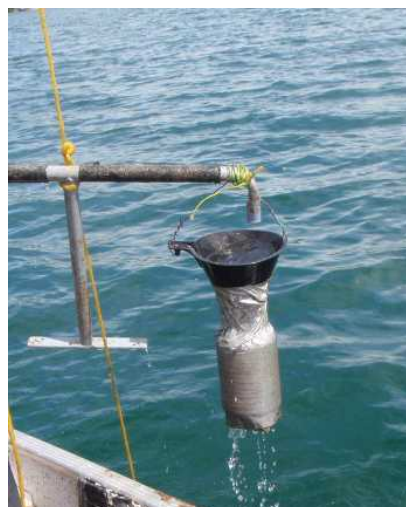
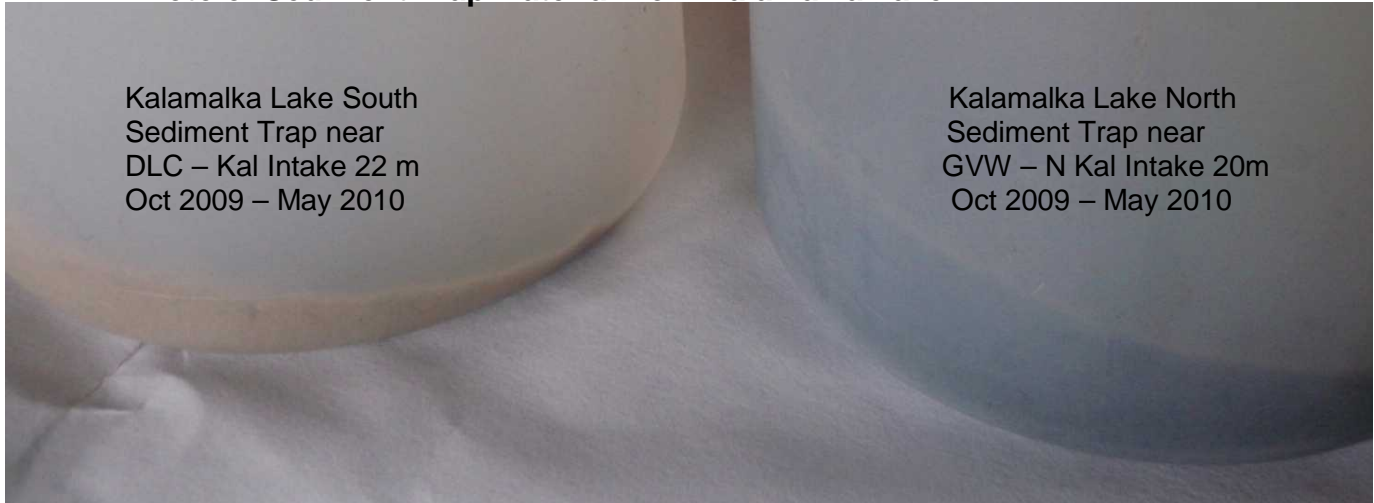
## Photo of Sediment Trap Material from Kalamalka Lake

The South Kalamalka Lake sediment trap showed a moderate sediment accumulation rate because there was no sediment source such as a stream or a storm water outfall nearby (Table 2.4). The trapped material demonstrated an accumulation rate of 21 g/m<sup>2</sup>/yr of which 15.2% was volatile (organic). The sedimentation rate at this site was one third of the rate at the GVW intake in the North Arm because the north site is influenced by the riparian damage along Coldstream Creek.

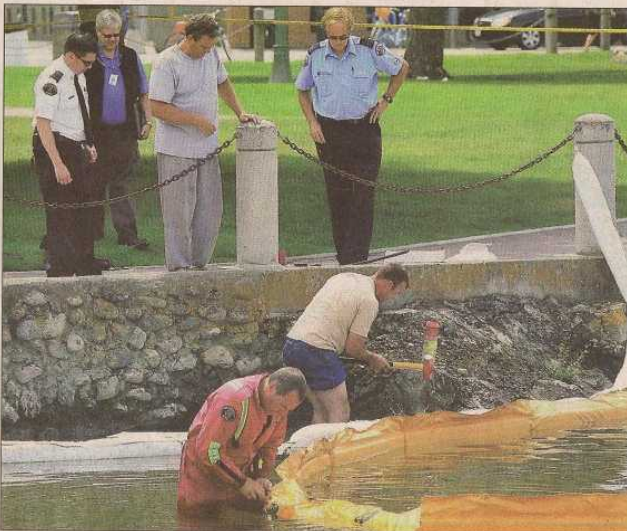
KELOWNA FIREFIGHTERS work Monday afternoon at Kerry Park to contain a gasoline fuel tank leak into Okanagan Lake.

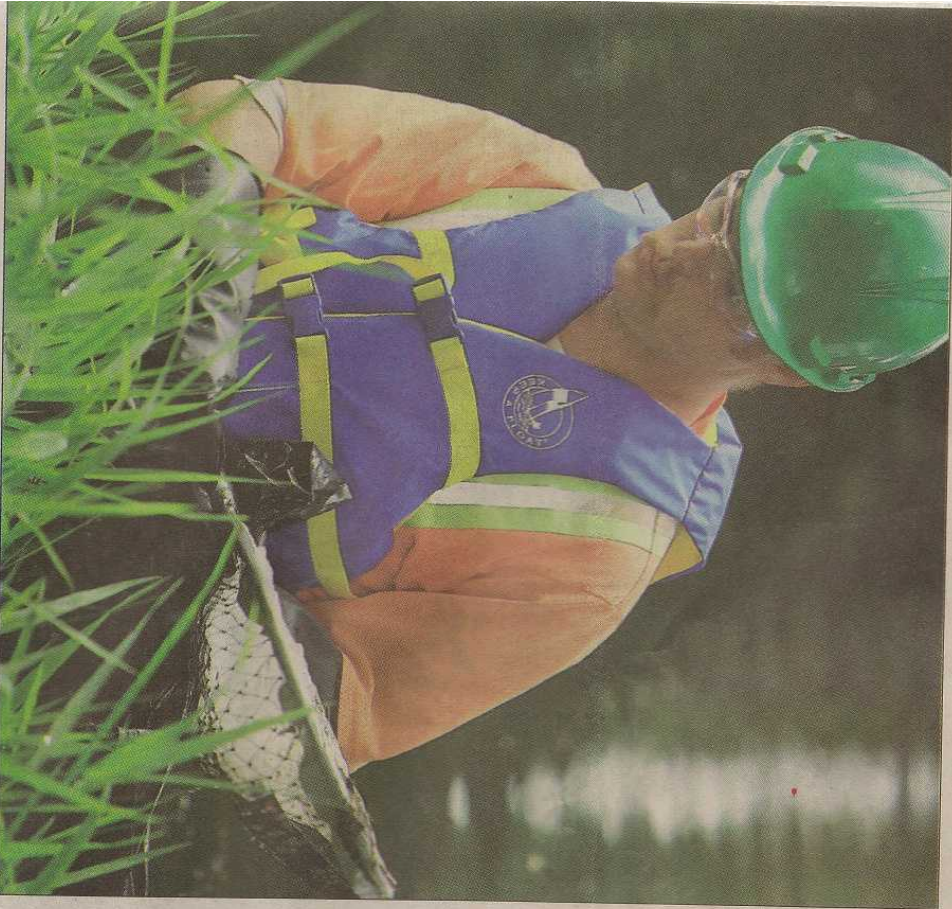
**MADING UP** to his waist in Mill Creek near the entrance to Okanagan lake, an environmental remediation worker inspects and removes debris from the creek after hazardous chemicals from the Stewart Centre fire on Saturday night were washed into the creek through the city's drainage system from the water used to douse the blaze.
